PHOTOGRAPHIC LOG		
Client Name: CPG		Site Location: Lower Passaic River (River Mile 10.9)
Project No. 60270961		
Photo No. 1	Date: 20160121	
Direction Photo Taken: Northwest		
Description: Representative distance of samplers from shore and icy bank conditions (looking towards station 15A-0605). Arrow pointing to location of 15A-0605.

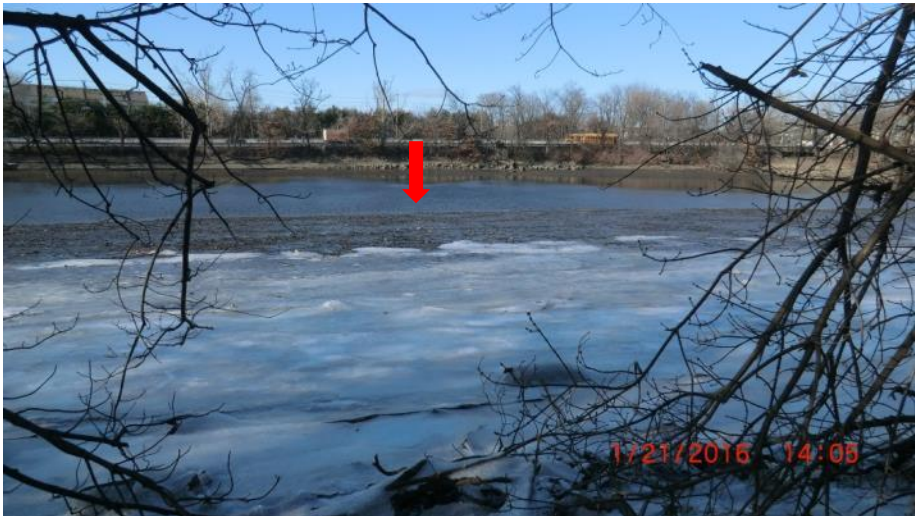
Photo No. 2	Date: 20160121	
Direction Photo Taken: North		
Description: Representative distance of samplers from shore and icy bank conditions (looking towards station 15A-0604). Arrow pointing to location of 15A-0604.

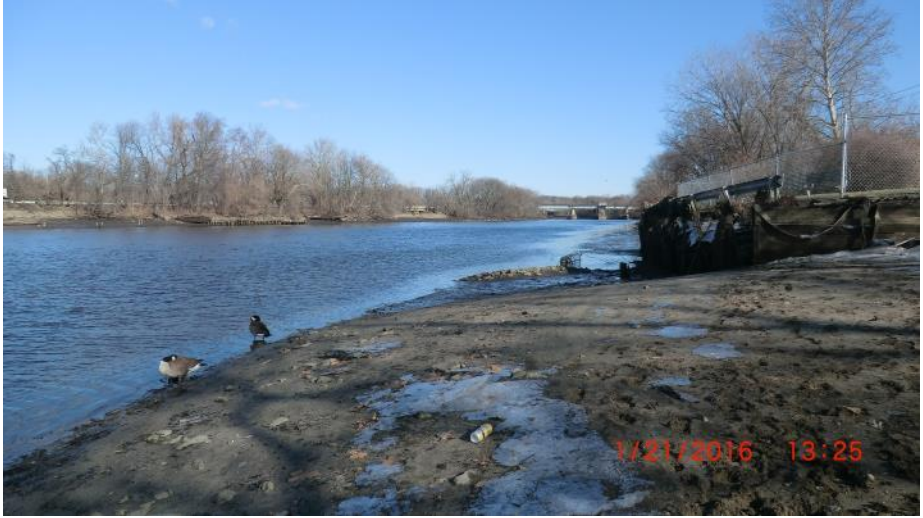
PHOTOGRAPHIC LOG		
Client Name: CPG		Site Location: Lower Passaic River (River Mile 10.9)
Project No. 60270961		
Photo No. 3	Date: 20160121	
Direction Photo Taken: East		
Description: Looking upstream from station 15A-0608 at low-tide.

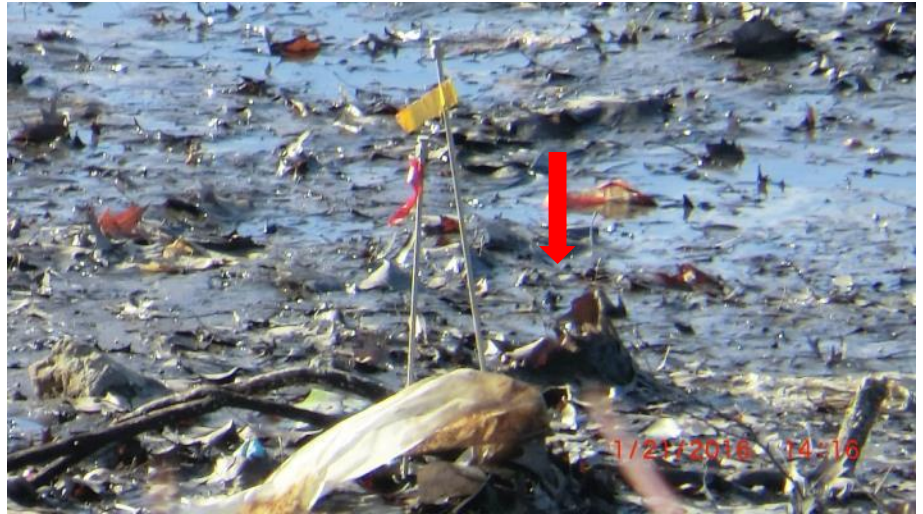
Photo No. 4	Date: 20160121	
Direction Photo Taken: West		
Description: Station 15A-0601 from shore. Green tagged sampler (underlying sediment) is obscured by debris. Arrow pointing to approximate location of underlying sediment sampler.

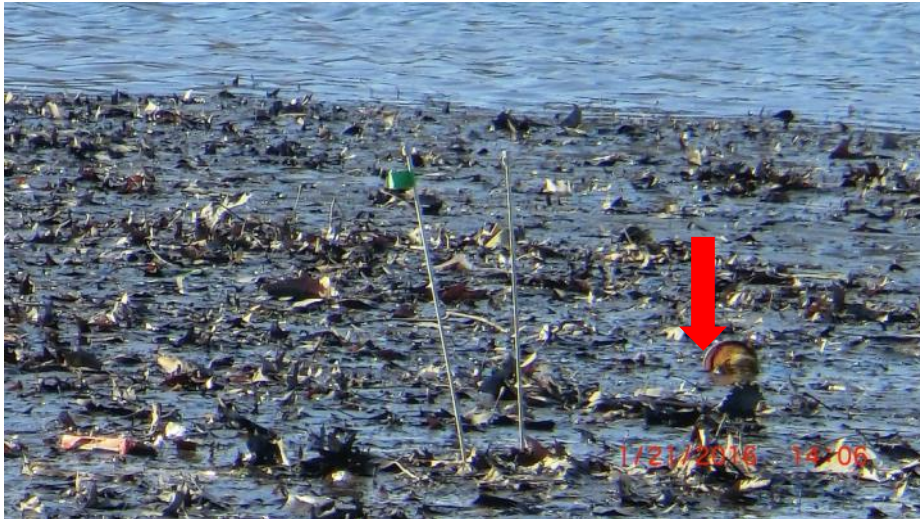
PHOTOGRAPHIC LOG		
Client Name: CPG		Site Location: Lower Passaic River (River Mile 10.9)
Project No. 60270961		
Photo No. 5	Date: 20160121	
Direction Photo Taken: Northwest		
Description: Station 15A-0603 from shore. Arrow pointing to approximate location of red tagged sampler (armor layer), which was not visible from shore.

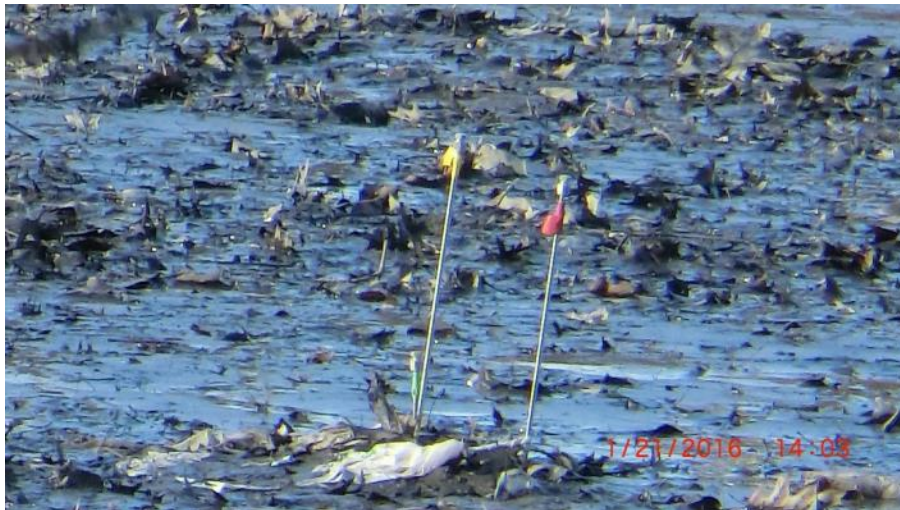
Photo No. 6	Date: 20160121	
Direction Photo Taken: Northwest		
Description: Station 15A-0604 from shore. All three samplers present.

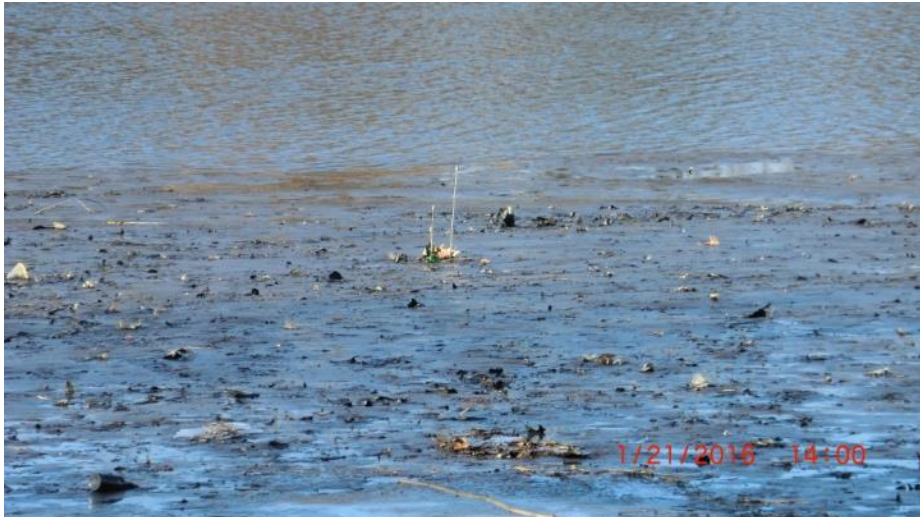
PHOTOGRAPHIC LOG		
Client Name: CPG		Site Location: Lower Passaic River (River Mile 10.9)
Project No. 60270961		
Photo No. 7	Date: 20160121

Direction Photo Taken: Northwest		
Description: Station 15A-0605 from shore. All three samplers present.

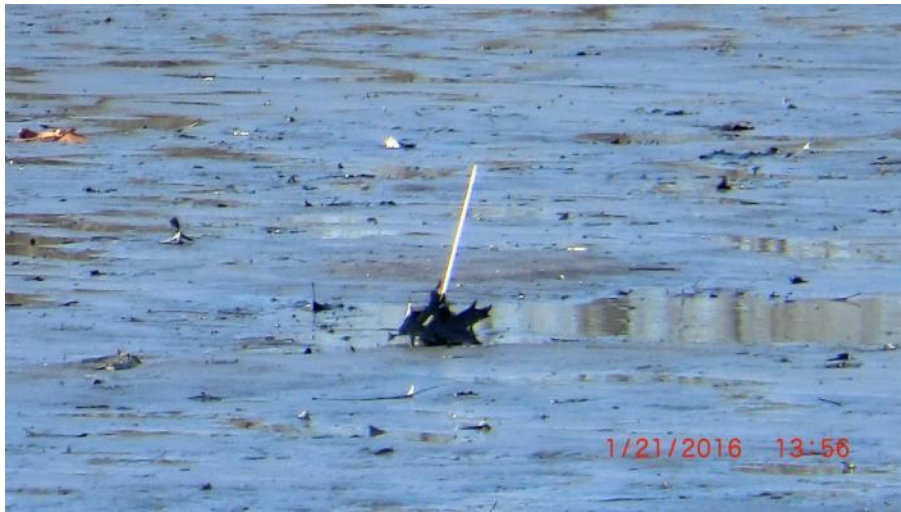
Photo No. 8	Date: 20160121

Direction Photo Taken: North		
Description: Station 15A-0606 from shore. Station distance from shore and debris prevented observation of the condition of the samplers.

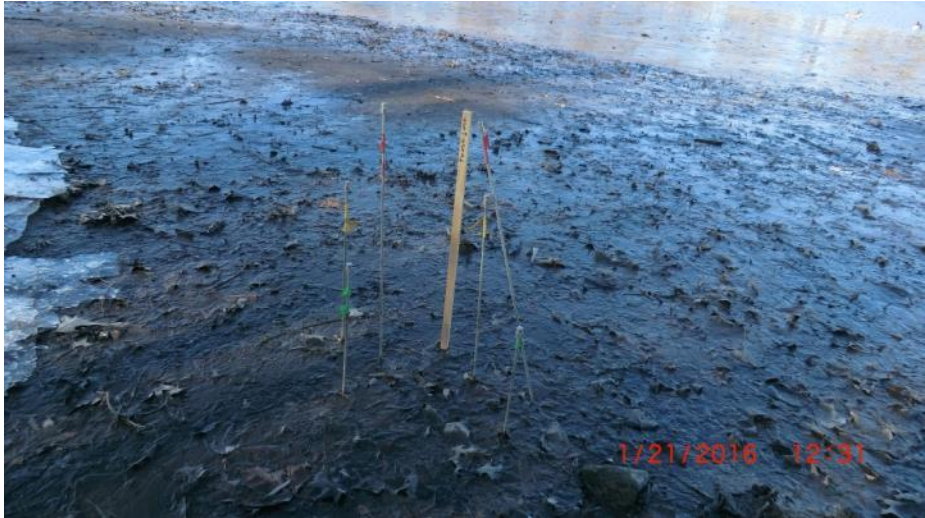
PHOTOGRAPHIC LOG		
Client Name: CPG		Site Location: Lower Passaic River (River Mile 10.9)
Project No. 60270961		
Photo No. 9	Date: 20160121

Direction Photo Taken: North		
Description: Station 15A-0607 and 15A-0607D (duplicate) accessed by foot. The red tagged sampler (armor layer) for 15A-0607 is at an approximate 65 degree angle.

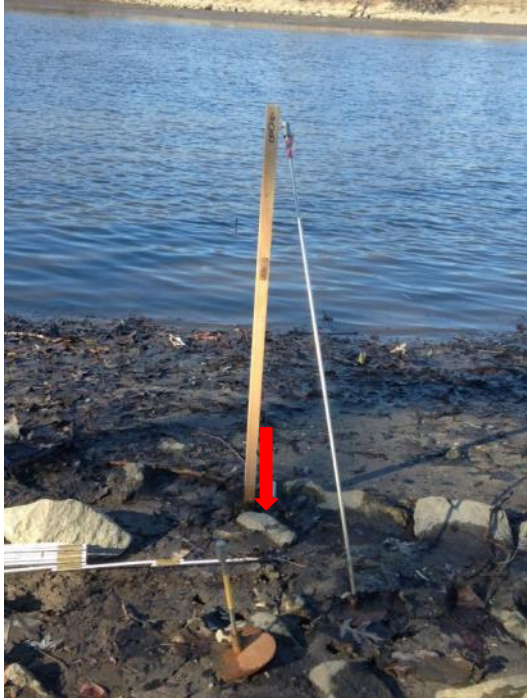
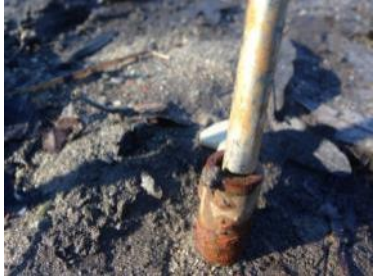
Photo No. 10	Date: 20160121

Direction Photo Taken: North			
Description: Station 15A-608 accessed by foot. Right picture showing red tagged sampler's (armor layer) top of well screen is above sediment. Left picture showing red tagged sampler (armor layer) is slightly bent. Green tagged sampler's (underlying sediment) cap is barely visible above sediment.
